# UPPER POST LAKE SOUTH SHORE LANDING IMPROVEMENTS

(August 7, 2021)

## ISSUES WITH THE LAUNCH AREA

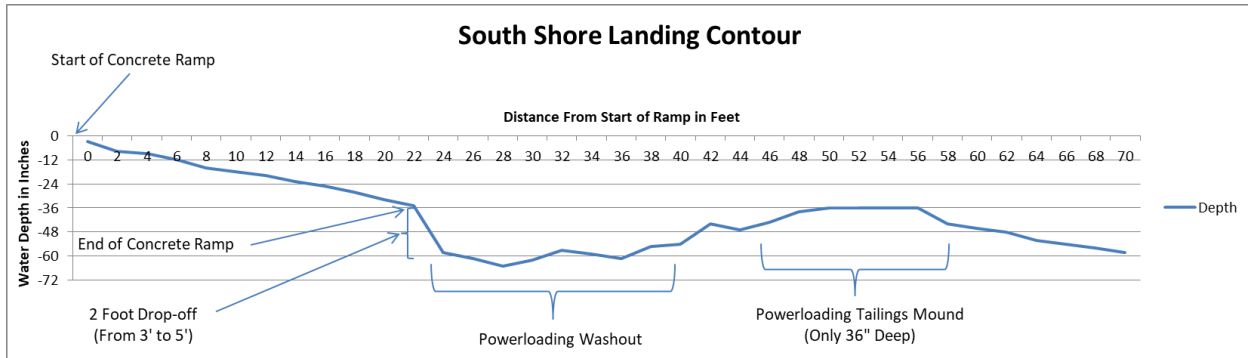
1. The launch has an 18' to 20' long washout at the lake side end of the concrete ramp. This washout is caused by people power loading boats onto their trailers. The washout drops from 3 feet at the end of the concrete ramp to more than 5 feet in depth. The washed-out materials have been deposited in a 20-foot long tailings mound, located approximately 40 feet from shore. This tailing mound has a depth of as little as 3 feet. Please see the contour mapping above. Boat trailers have been known to get hung up on the ramp drop-off and boat motors props often hit the tailings mound.

2. Each year winter Ice pushes the existing concrete boat ramp further and further onto shore. The Town of Elcho maintenance staff has been able to manage this issue by adding gravel to the front of the ramp to smooth out the ramps transition to the gravel approach.

1. Do nothing and wait until problems become unmanageable.
2. Fill-in the washout area with 6" to 24" clean quarry stone and remove the tailings pile. There would be no DNR permit required should the Lake District elect to manually remove the tailings pile with hand shovels and pails (No Excavating Equipment). If excavation equipment is to be used to remove the tailing pile a DNR Dredging Permit would be required at a cost of \$303. This approach does not address the runoff management issues, the ADA issues, or the ice push issue.
